Manhole Inspection Summary

Manhole # S13II2022MH

Location Address: **2100 NORTHCLIFF DR**

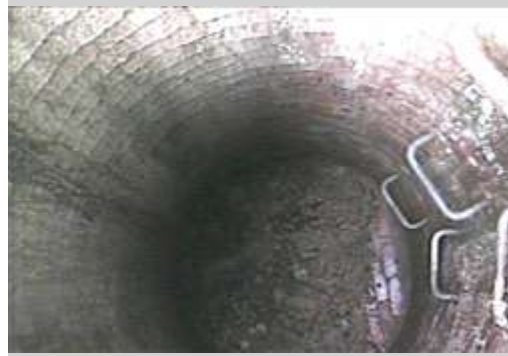
Top View

Channel debris.

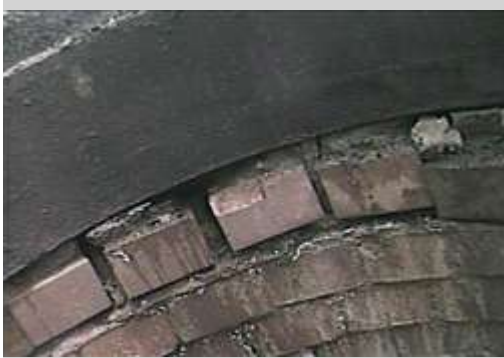
Defect

Frame leaks. Adjustment deterioration, loose brick, and infiltration.

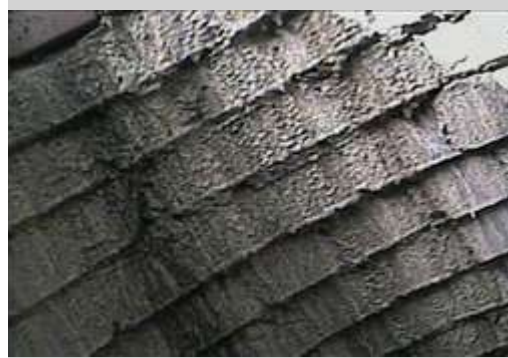
Defect

Adjustment and Corbel infiltration.

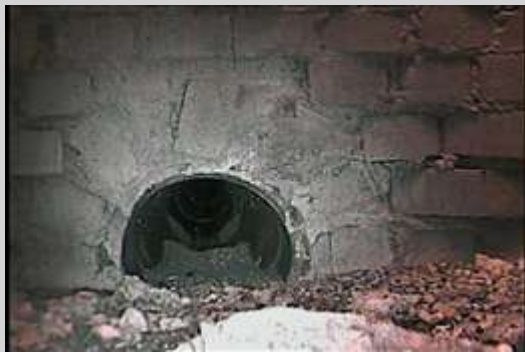
8 in. Circular Gravity Sewer
Pipe Out @ 12 O'Clock

Barrel infiltration.
